WARNER HALL CEMETERY ASSESSMENT, GLOUCESTER COUNTY, VIRGINIA

Research Contribution 593

November 2018

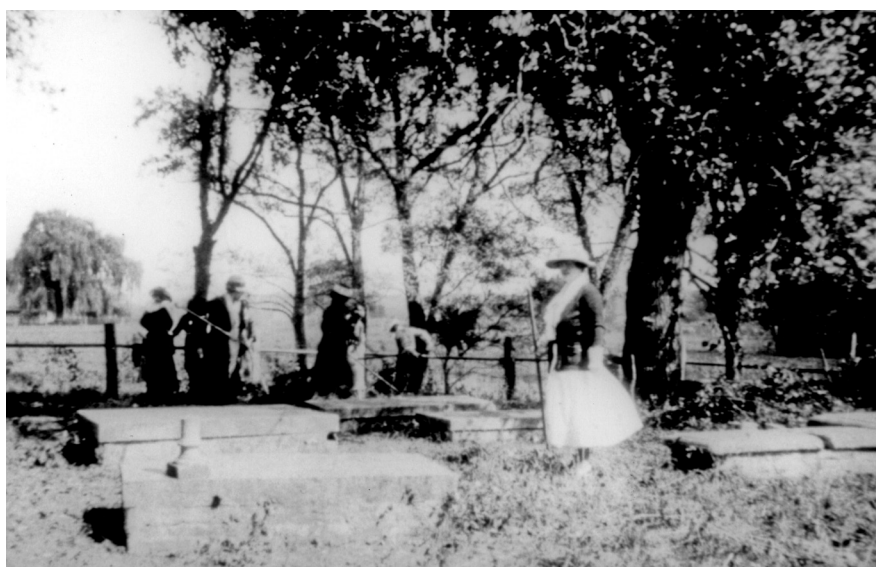
Figure 3. Early cemetery photographs. At the top is the cemetery in 1903 (*The Times Dispatch*, Richmond, VA, June 28, 1903, pg. 14). Below is a photograph identified only as “early twentieth century photo” (likely 1907-1908)(Preservation Virginia).

and were they replaced by easier to build brick? There is a photograph associated with the article, although its poor quality provides few clues (Figure 3). There is another photograph that, while undated, is likely only slightly more recent, perhaps 1907 or 1908, taken as the APVA began its cleanup of the cemetery.

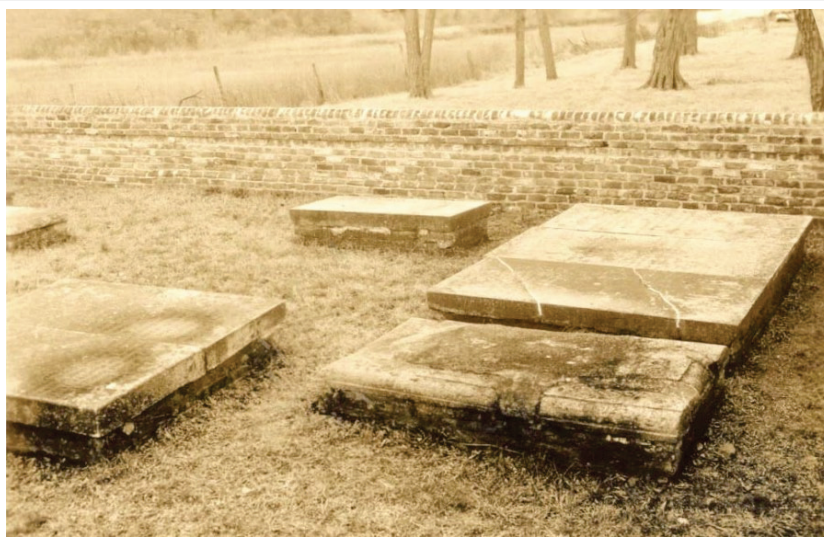
Figure 4. Warner Hall Cemetery in 1935 (Mildred Warner-Washington National Monument Collection, 1934-1937: File No. 0-32, Colonial National Historic Park, Yorktown).

There was a photograph, dating from 1935 that shows a small portion of the cemetery (Figure 4). Of particular interest in the ledger in the lower right, today identified as Mildred Reade Warner. Although the inscription is not visible, it reveals that by the first quarter of the twentieth century this monument was present and poses the question of why it was not identified by Tyler only about 40 years earlier. It also appears that the ledger is marble, not limestone, suggesting a more recent placement than the surrounding low brick box tombs.

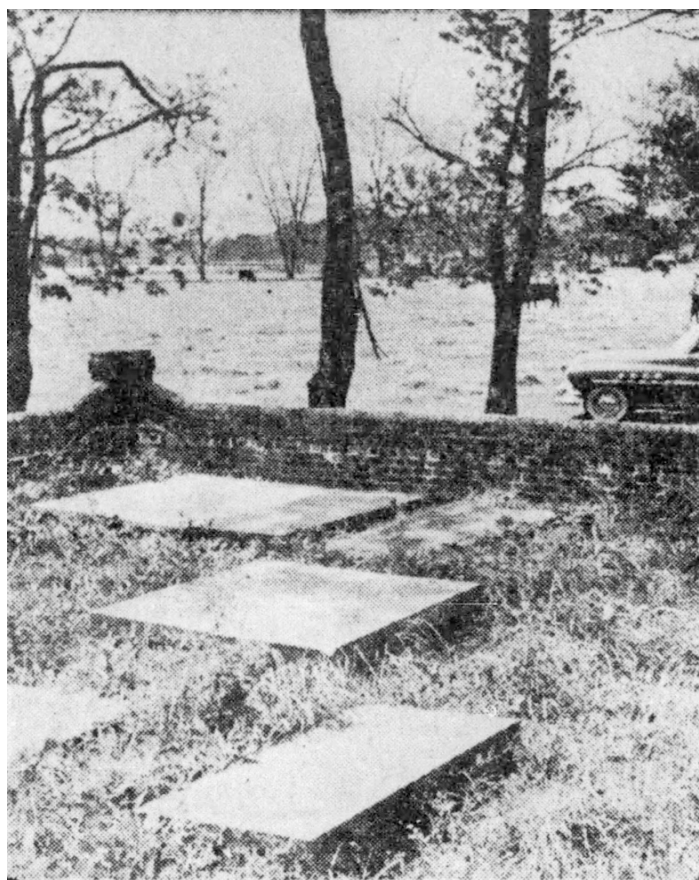
Figure 5. Warner Hall Cemetery in 1954, looking to the west
(*Daily Press*, Newport News, VA, April 27, 1954, pg. 14).

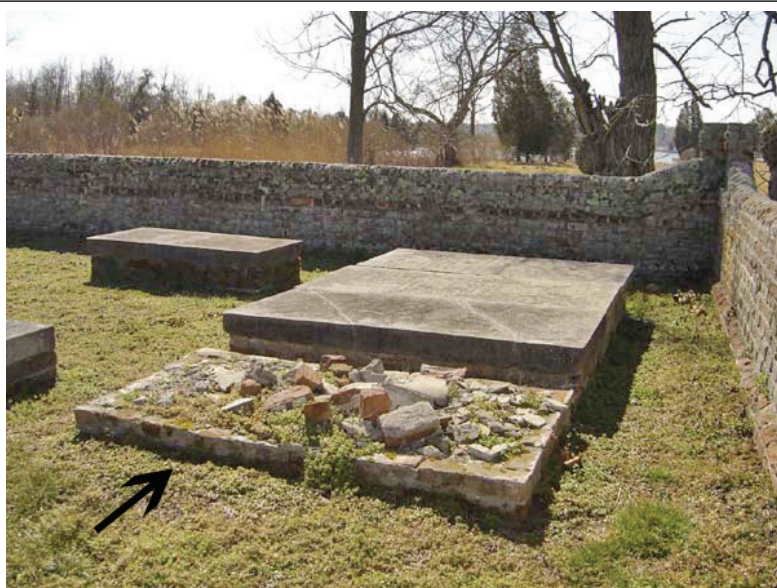
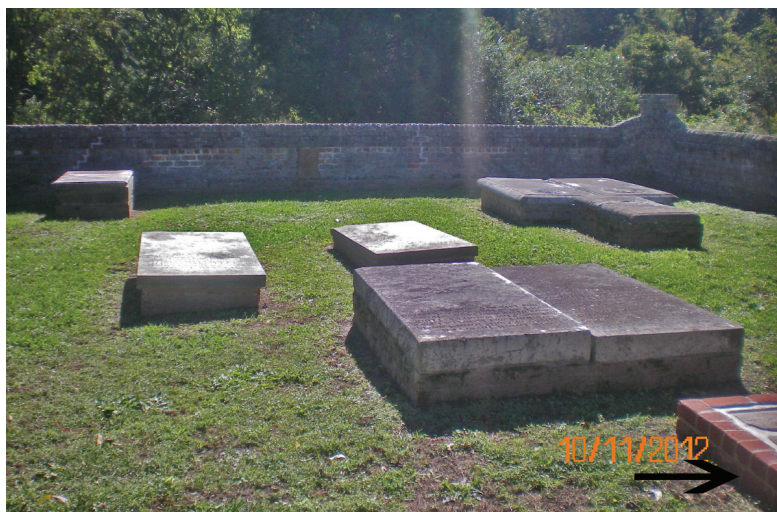
Figure 7. Photographs of the cemetery in the early 2000s. The upper photo is reported to date from 2007 (from Find-A-Grave). The lower photo is time stamped 2012 (from the Gloucester County Tax Assessor).

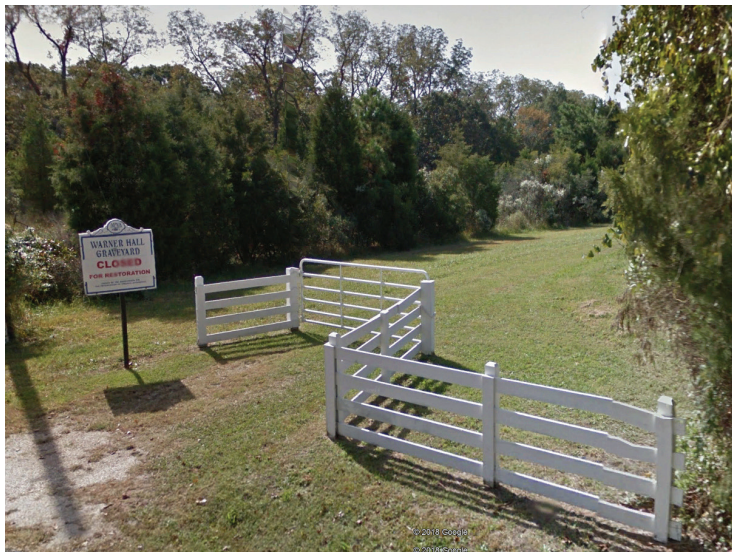
The 1967 court defined easement, 12-feet in width, provides vehicular access to the cemetery. This access, entirely grassed and only occasionally used, is not obvious (i.e., there is not a dedicated, obvious roadway from this point to the cemetery) except for a gate on Warner Hall Road, about 0.25 mile southeast of the main plantation entrance and about 0.05 mile southeast of the owner's driveway. There is a farm gate and sign at this entrance (Figure 13). It also passes over a low slough that is occasionally wet; this may hinder some vehicular traffic.

Figure 13. View of the easement entrance in 2012, after the destruction of the pedestrian stile (never replaced) and damage to the gate.

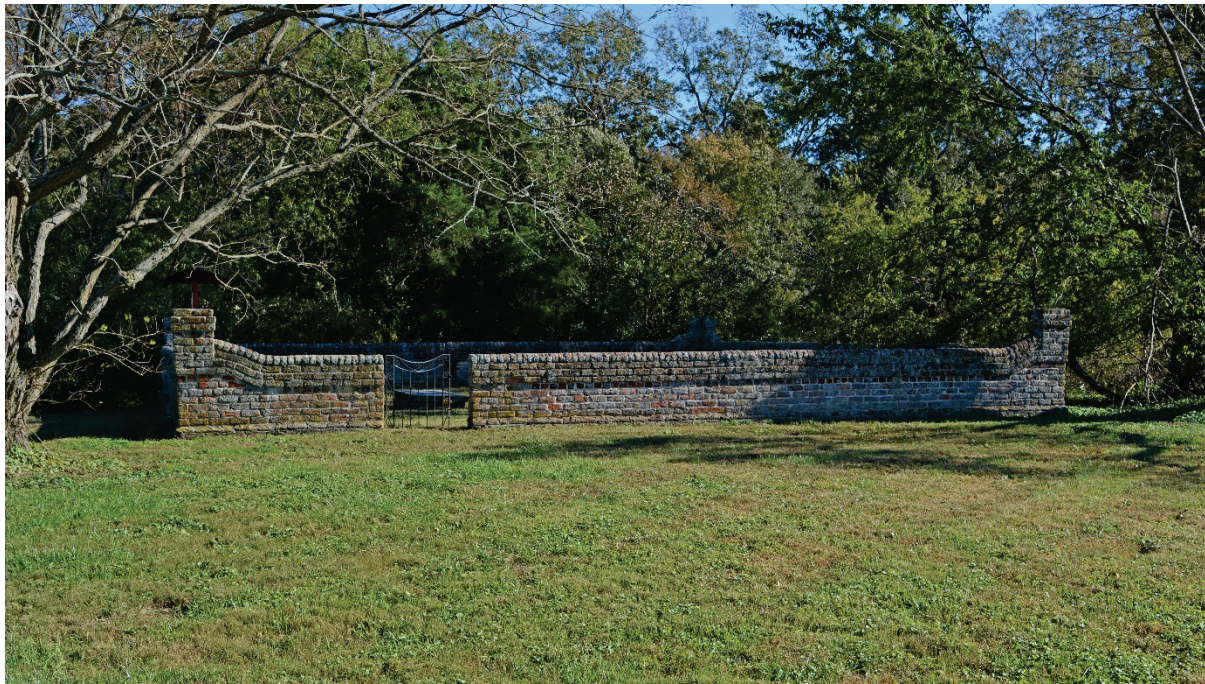
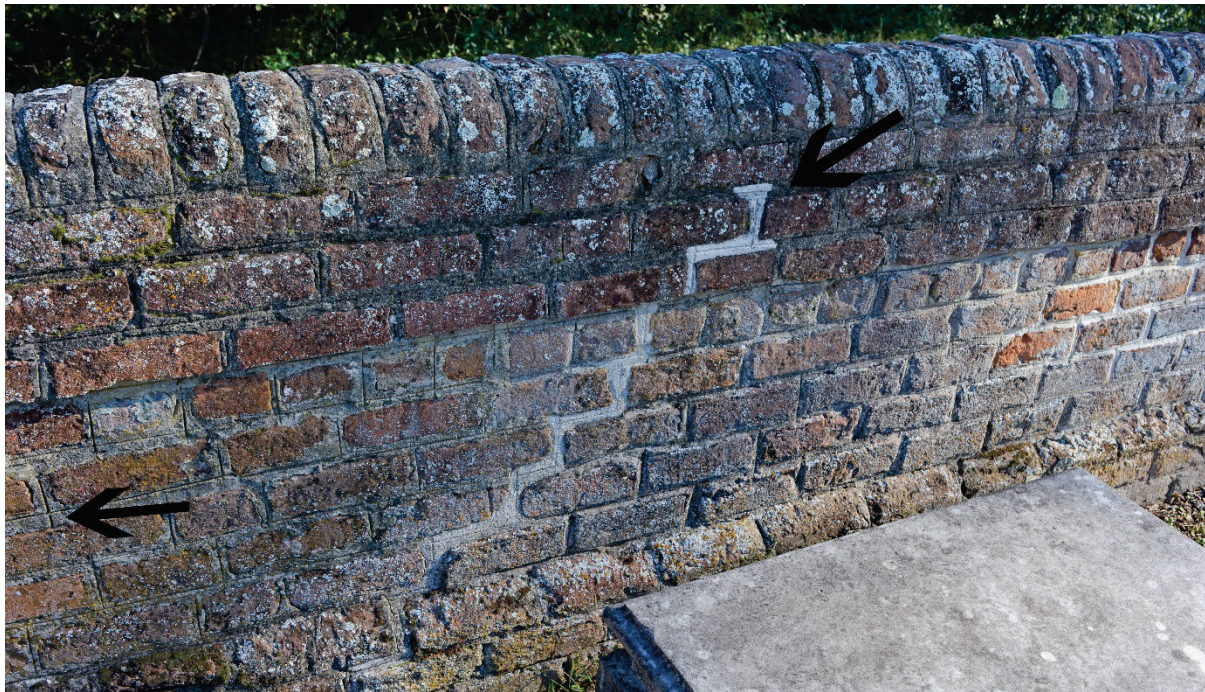
Figure 15. Cemetery wall. Top photo shows the design of the wall, looking southeast. Lower photo shows a section of the northeast wall interior. The arrows note a poor job pointing a crack and also how the joints have been improperly struck.

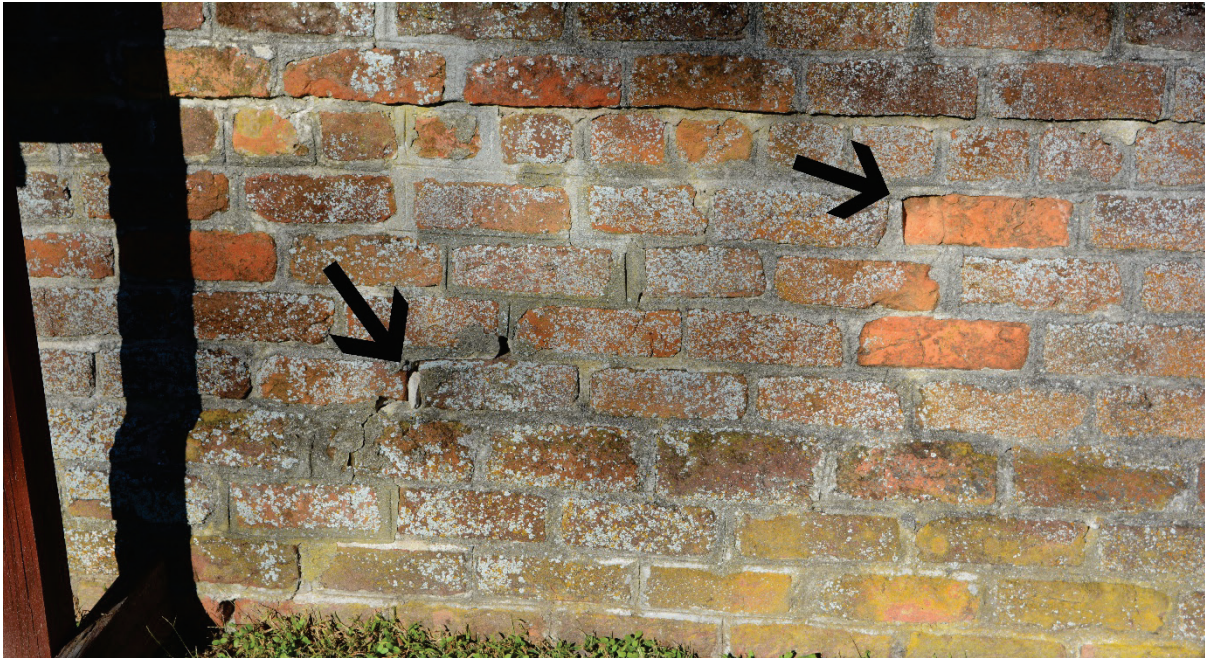
Figure 16. Cemetery wall. The upper photo shows an existing, open crack as well as a brick spalling as a result of the very hard mortar. The lower photo shows a poor match of both mortar and replacement bricks.

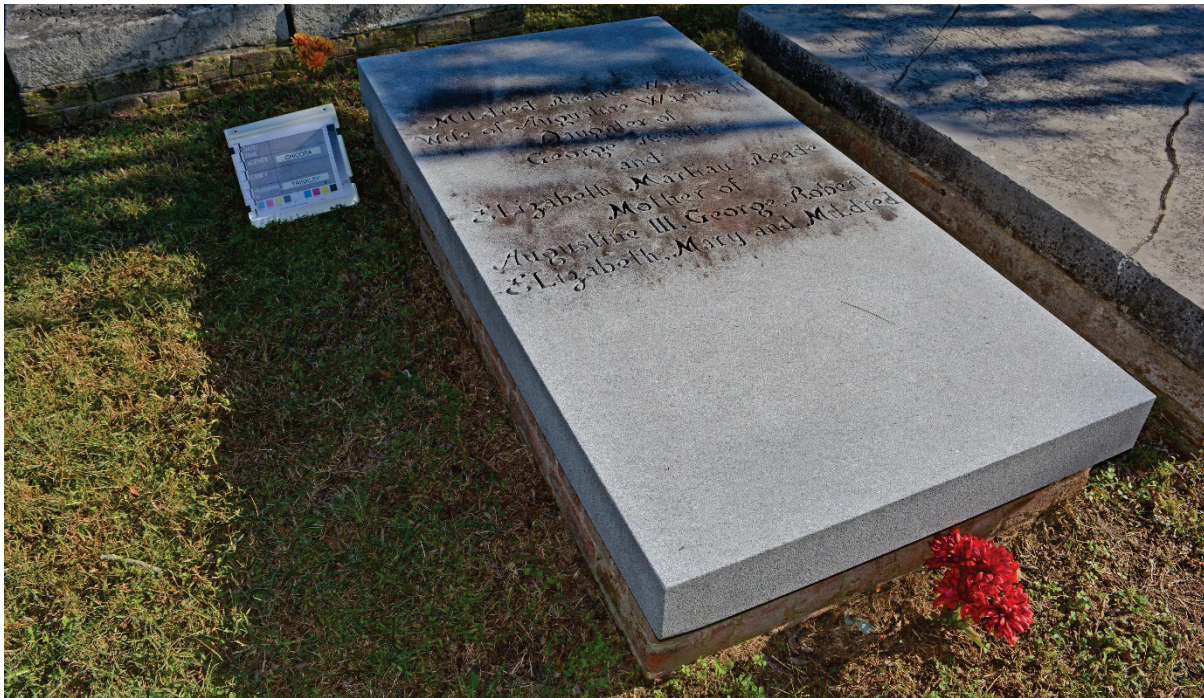
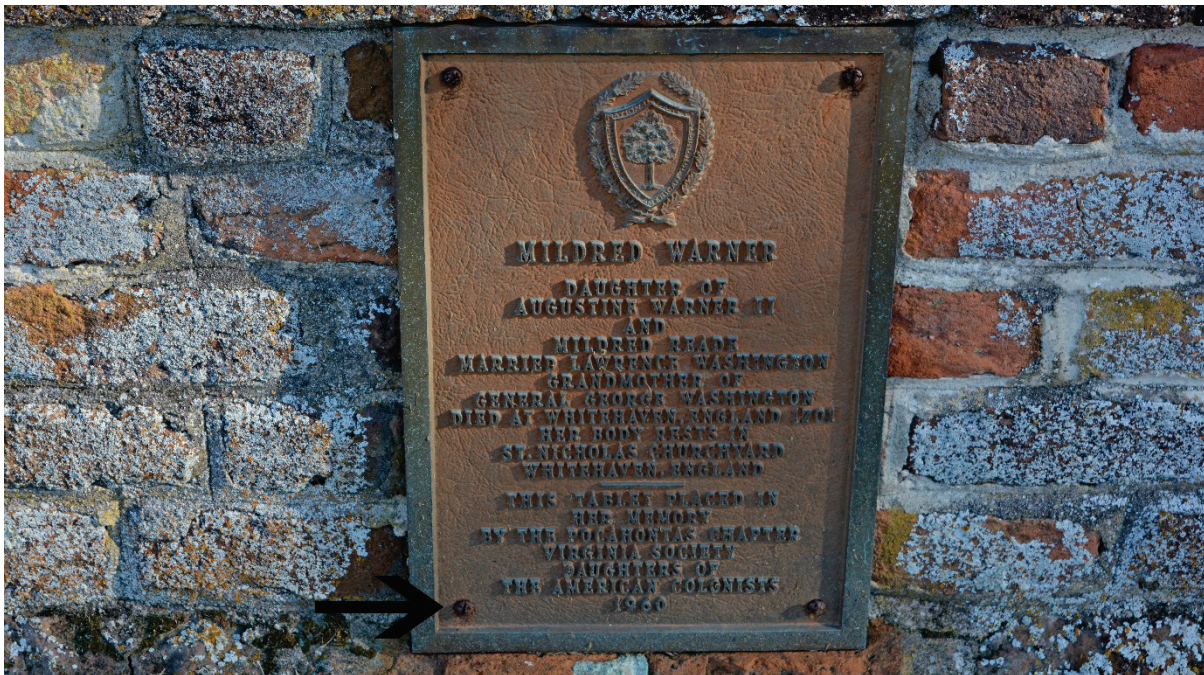
Figure 18. Inappropriate modifications. The top photo shows a modern granite marker that is discordant in the historic cemetery. The lower photo shows a plaque attached to the brick wall. Note also the corrosion of the bolt attachments.

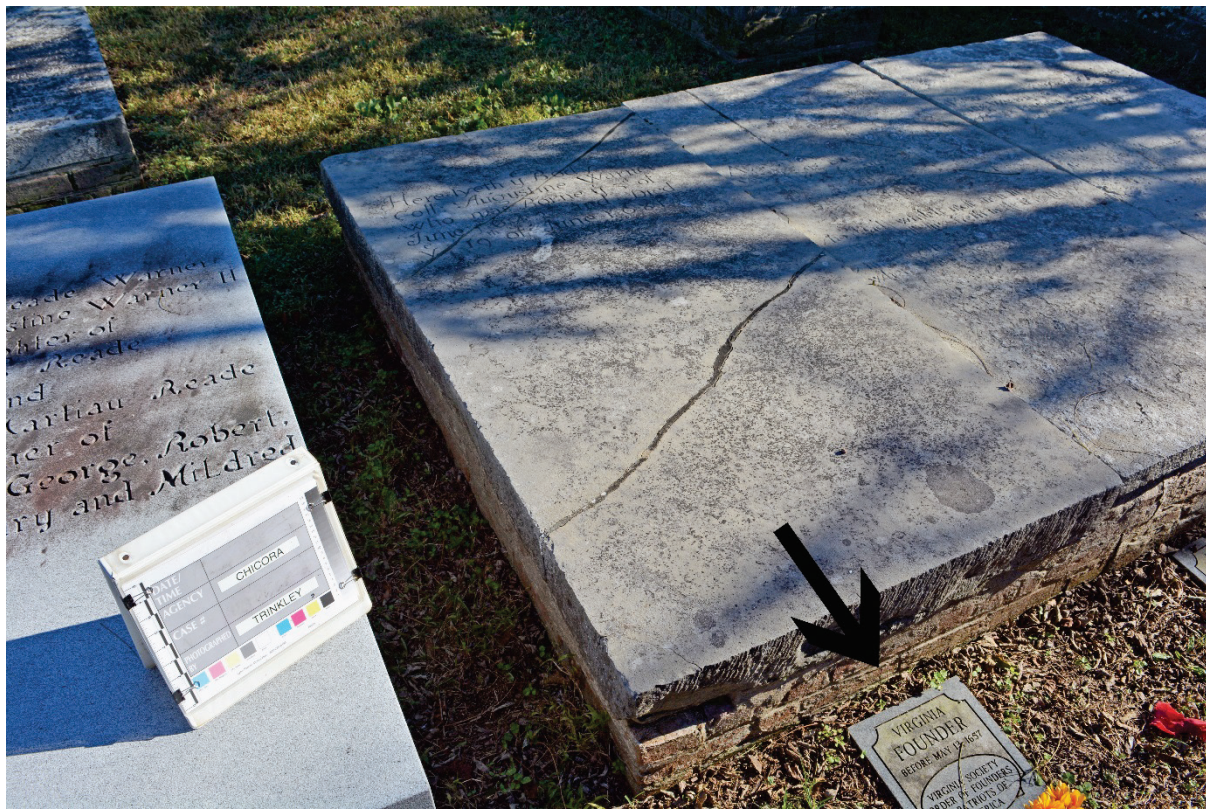
Figure 19. Appropriate addition. The small, unobtrusive flush to ground marker is an appropriate mechanism to provide additional information in a historic cemetery.

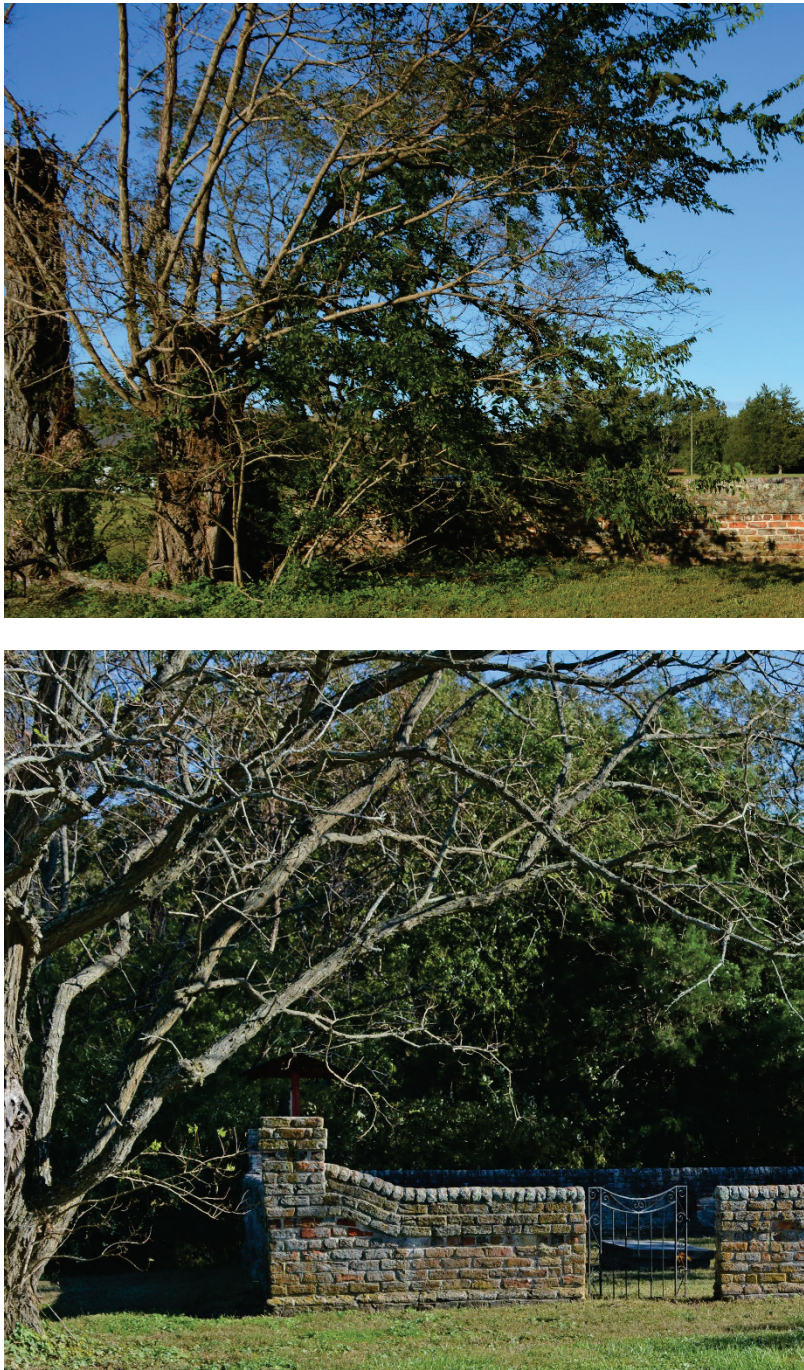
Figure 21. Tree issues. Upper photo shows the two nearly dead trees on the west side of the cemetery that should be removed. Lower photo shows the one tree on the east side of the cemetery that, if not removed, should be inspected by an ISA Certified Arborist on a yearly basis.

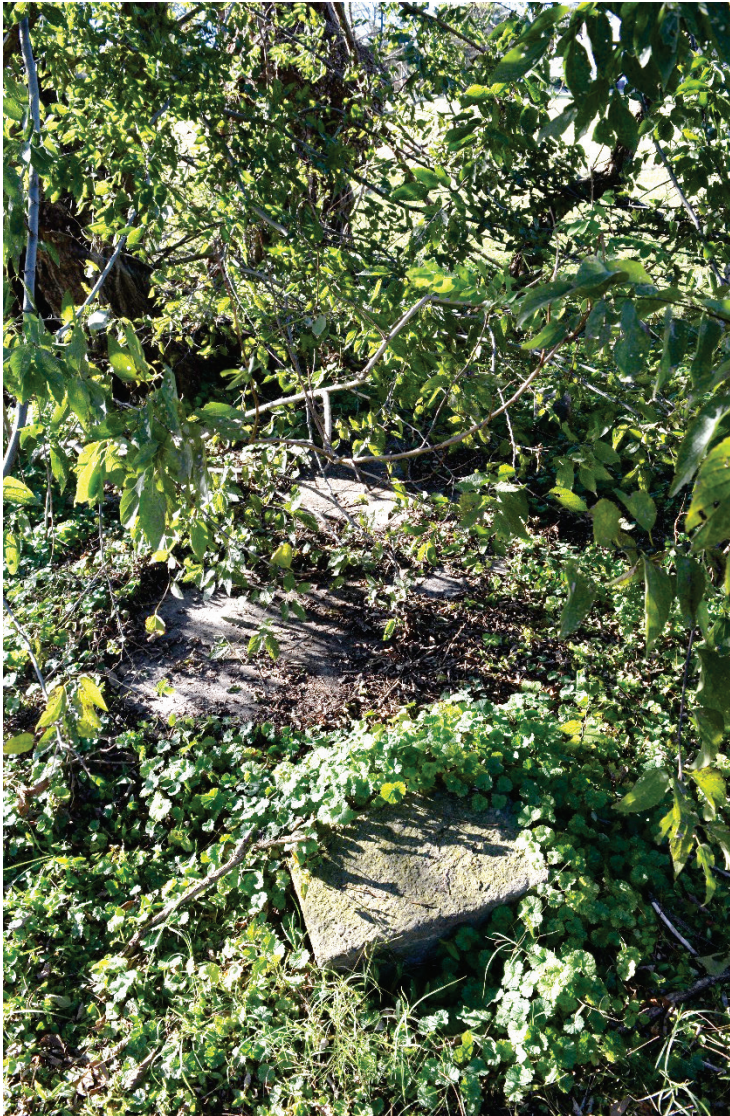
Figure 22. Brush surrounding the McLanahan monument base that must be removed so this area may be maintained in a fashion similar to the remainder of the cemetery easement.

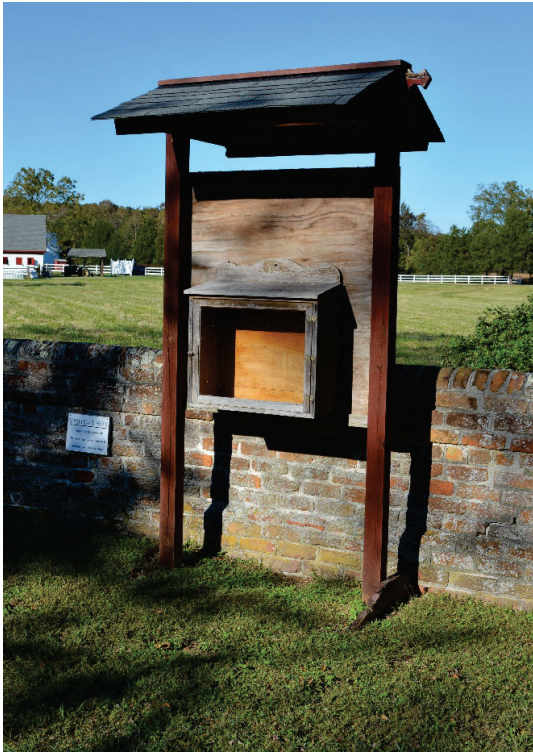
Figure 24. Signage board in the cemetery at the time of the assessment.

attached to the brick wall or freestanding at the wall. Figure 24 shows the current signage board.

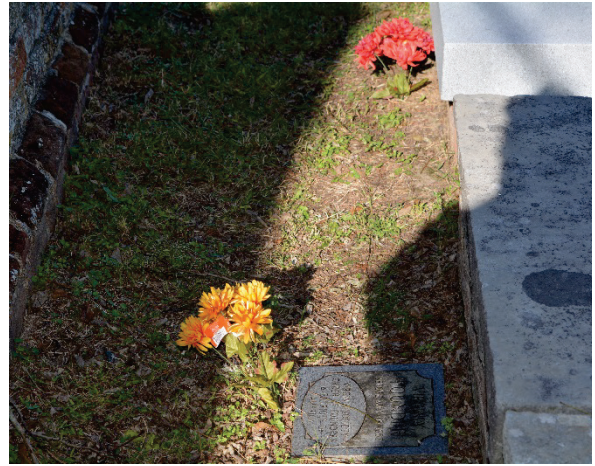
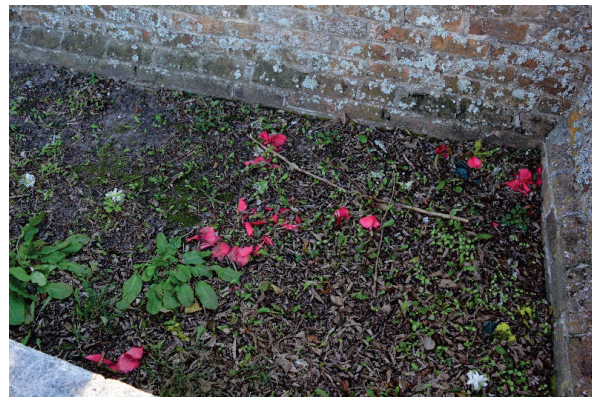
At the time of this assessment, we observed that silk flowers had been placed at several graves. While we understand that such activities are well meaning, they cause considerable problems. They become faded and eventually they are mowed or trimmed, spreading

Figure 25. Flower issues at the Warner Hall Cemetery. Photo at the top shows silk flowers placed in the colonial burial ground. Photo below shows debris from a flower arrangement that has been mowed over or trimmed.

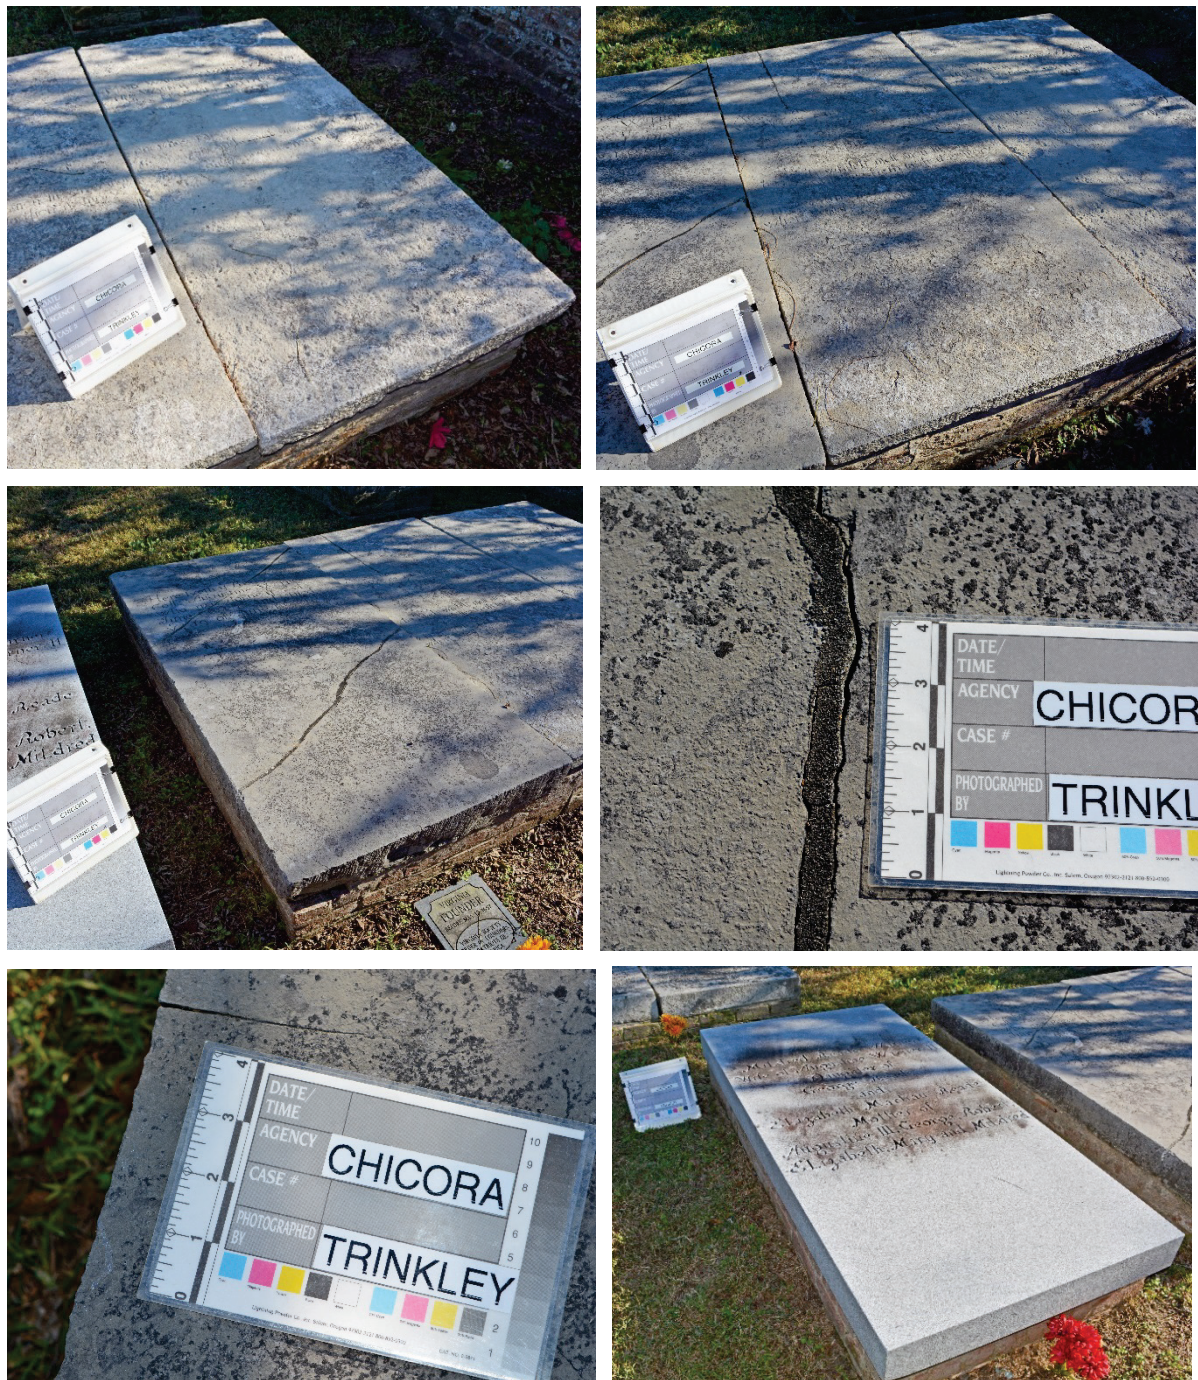
There are two cracks, or likely breaks. One runs from the upper right corner diagonally to the left side about 2-feet from the top. The second cracks runs across the midsection from right to left.

Figure 27. Ledgers 1-4 showing current conditions. Upper left, ledger 1; upper right, ledger 2; middle left, ledger 3, middle right, crack in ledger 3; lower left additional crack; lower right, ledger 4 replacement.

Both cracks have been shifted apart for the addition of a hard Portland cement (the lower one more so than the upper). The close up photograph in Figure 27 reveals that there is today a substantial crack between the stone and the Portland cement (present at both cracks). This will allow water penetration and will exacerbate freeze-thaw damage.

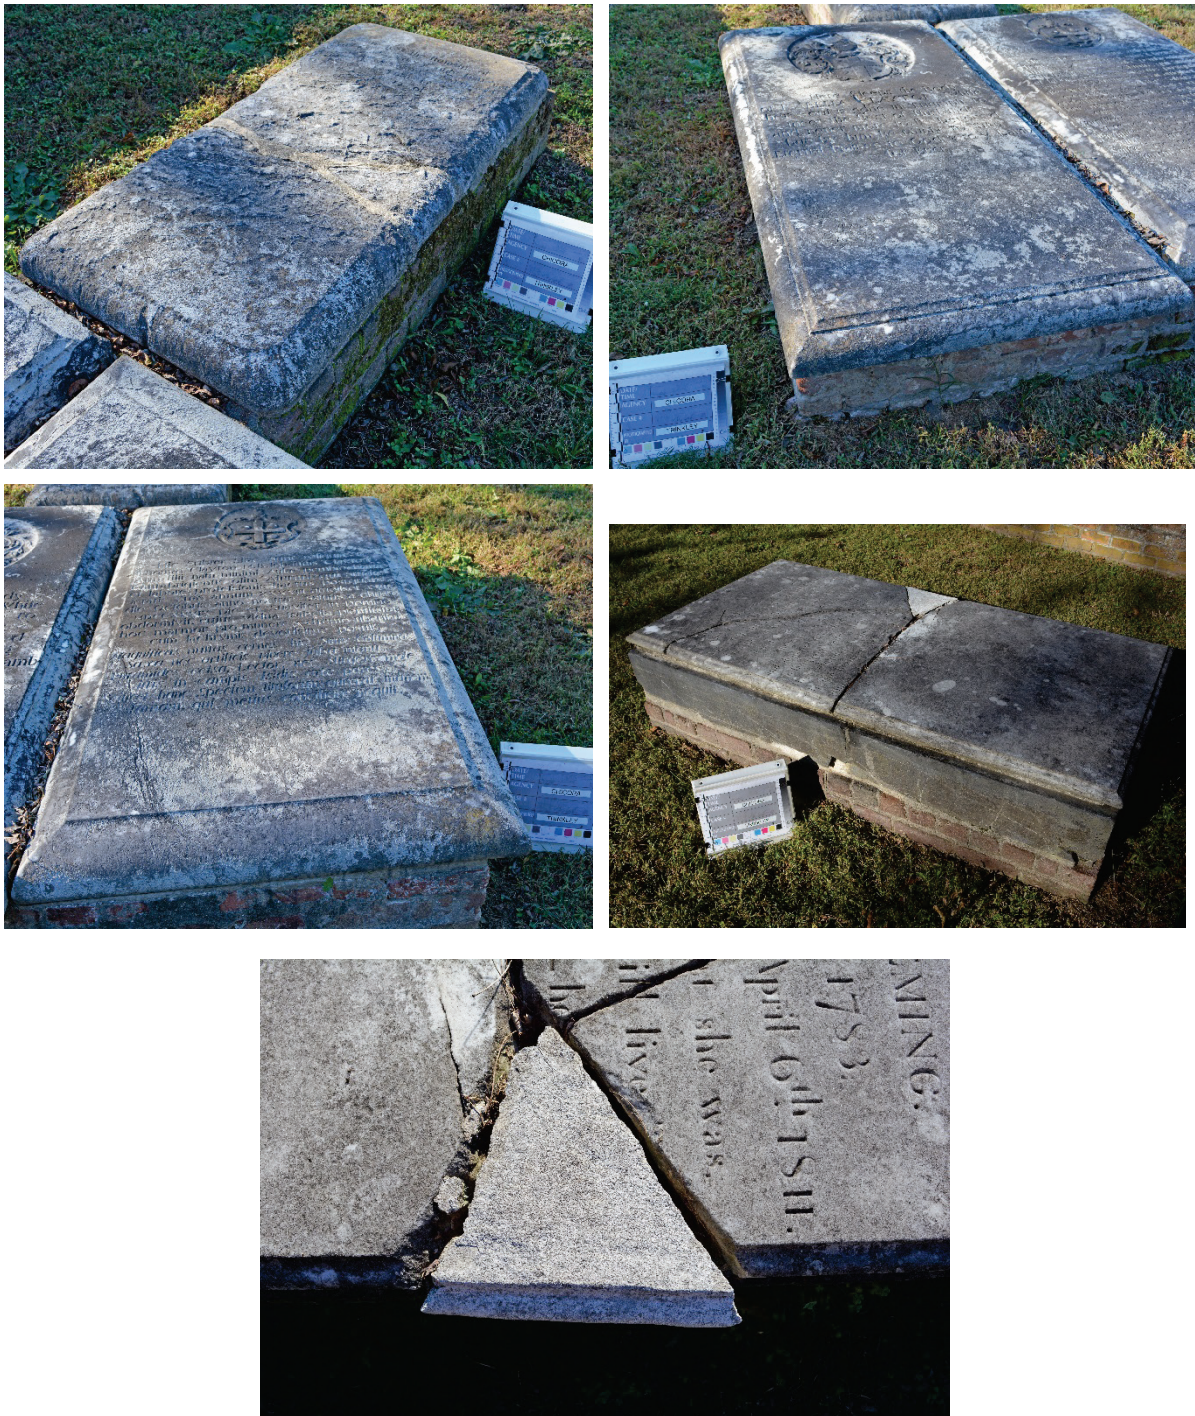
Figure 29. Ledgers 10-13. Bottom photo is a close-up of stone 13 showing the open breaks and infill section.

The breaks should be cleaned and tested for registration. It will likely be appropriate to drill the fragments for the insertion of fiberglass pins – a process called a blind pin repair. These pins will be set using a hi-mod, moisture insensitive structural epoxy and the ledger clamped until the pins are set. It will then be necessary to infill areas of loss using color-matched materials. Options include St. Astier Lithomex or Jahn M-120 Marble Mortar.

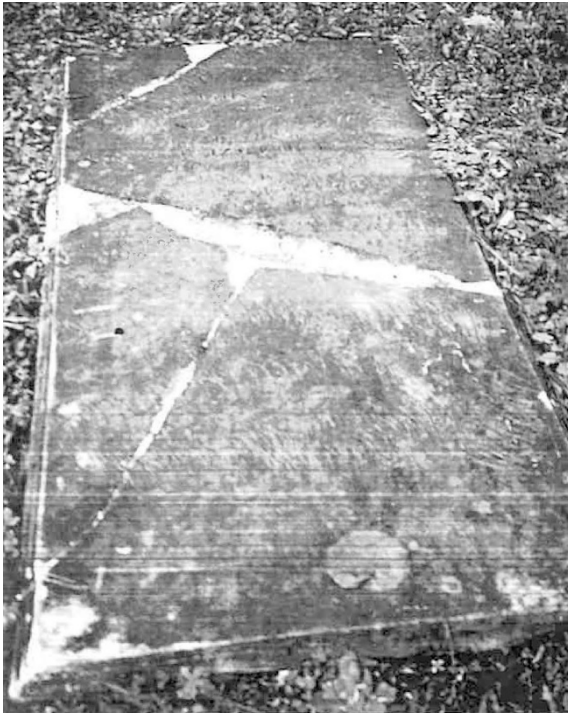
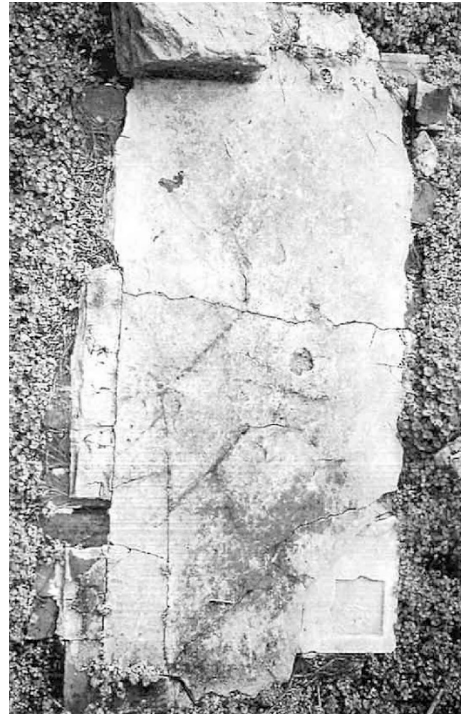
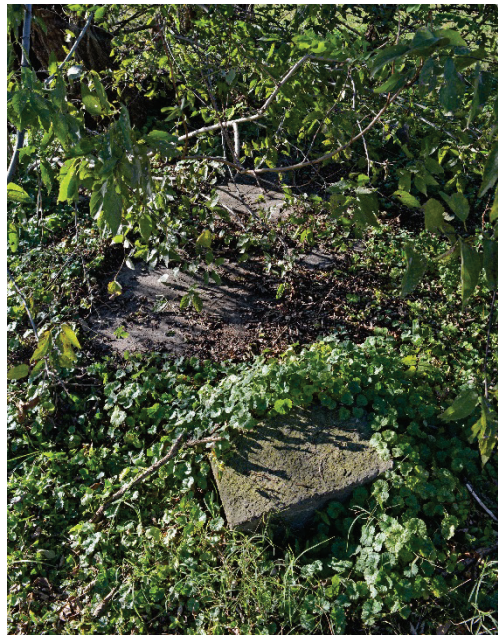
Figure 30. McLanahan grave and marker. The upper left photo shows the marker at Abington Church in 2004. The upper right photo shows what was left behind at Warner Hall. The lower photo shows these remains as they exist today.

The stone should continue to be monitored every 5 years.
